TRANSIT STOP SAFETY STUDY UPDATE

January 2013

**PARSONS
BRINCKERHOFF**

Regional Transportation Commission of Southern Nevada

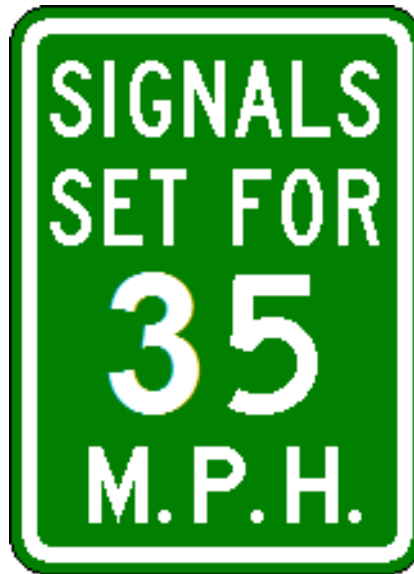
Figure 1: Signals Set For 35 MPH Sign

- Synchronizing traffic signals to turn green based off of a vehicle traveling at 35 mph. In other words, if a vehicle is stopped at a traffic signal and the signal turns green, that vehicle would have to stop at the next traffic signal if it traveled faster than an average speed of 35 mph between the consecutive traffic signals. The synchronization process could be accomplished through coordination between the local entities and the RTC’s Freeway and Arterial System of Transportation (FAST) department. Signage would be crucial in alerting drivers that the signals are set for a vehicle traveling at 35 mph. An example of a sign that could be used to alert drivers is shown in Figure 1.
- Increase the police enforcement along arterials with transit routes and pull over drivers that are speeding and running red lights.

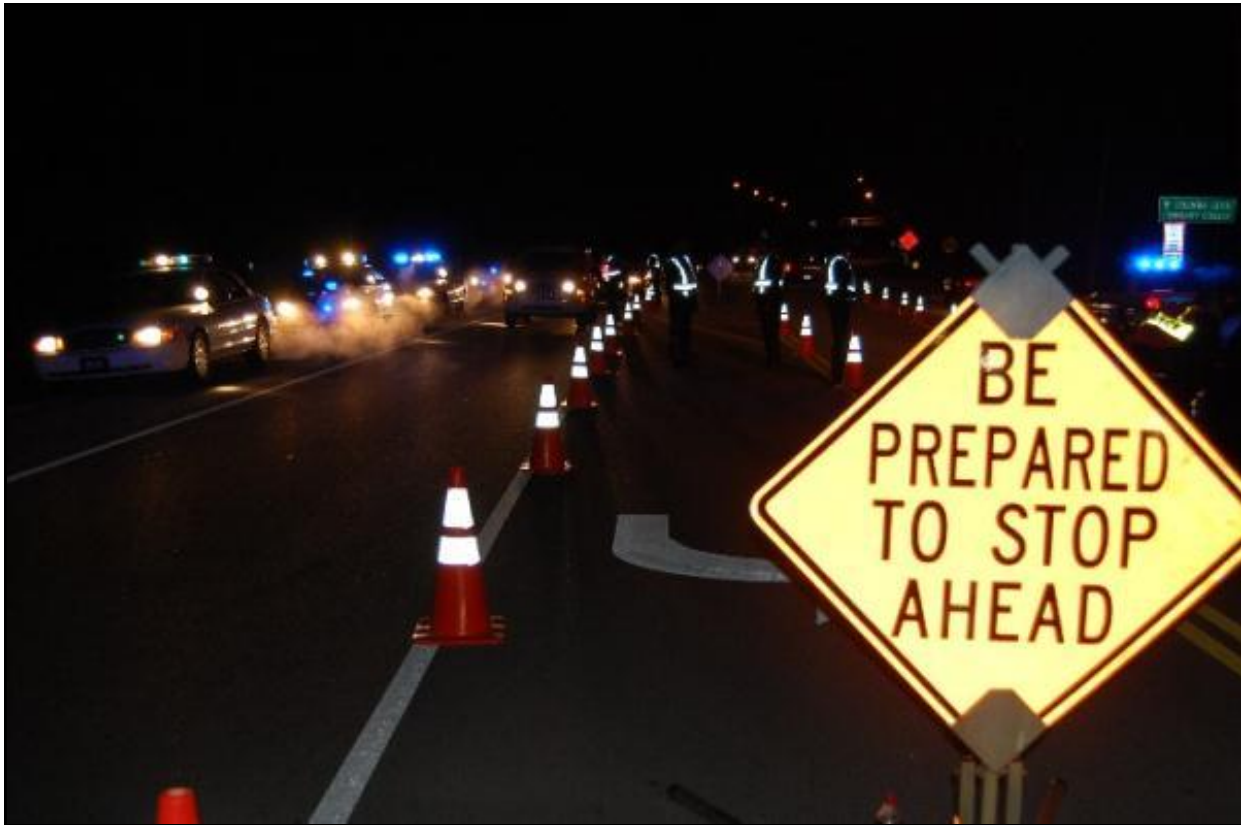
Figure 2: Sobriety Checkpoint¹⁰

Additionally, the Centers for Disease Control and Prevention (CDC) found that alcohol-related crashes were reduced by approximately 20% when sobriety checkpoints were implemented.⁹ An example of a sobriety checkpoint can be viewed in Figure 2.

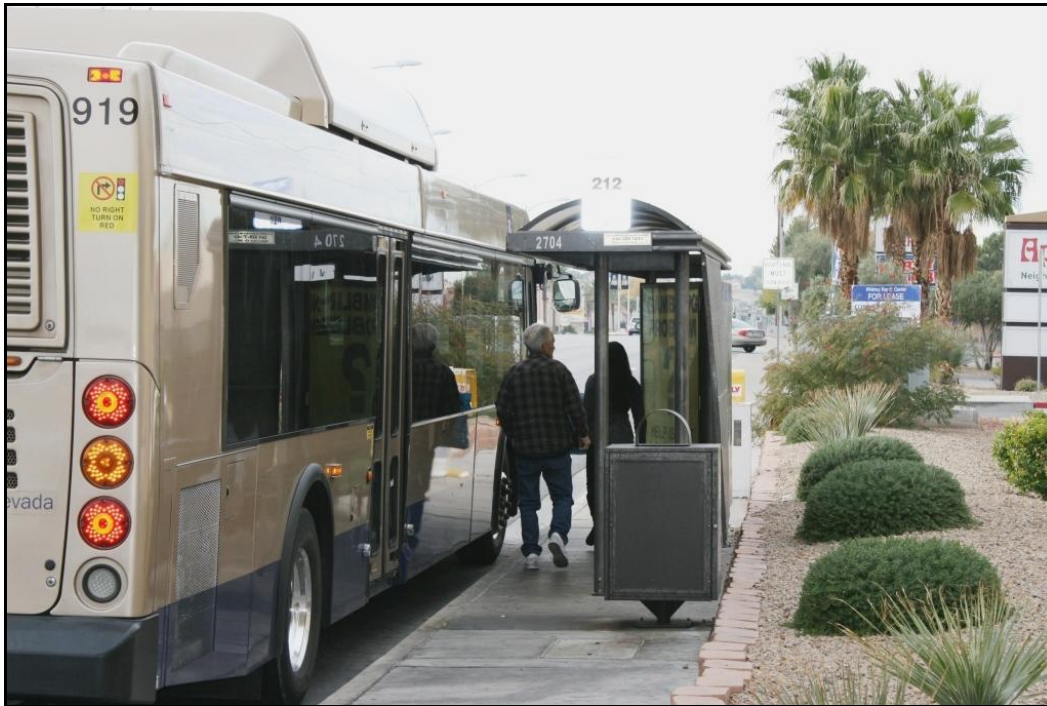
Figure 5: Las Vegas Valley Bus Shelter Located On Sidewalk

way to move bus stops back.”¹⁴ Figure 5 illustrates a bus stop that is located within the sidewalk, whereas Figure 6 illustrates a bus stop that is located on a bus pad behind the sidewalk.

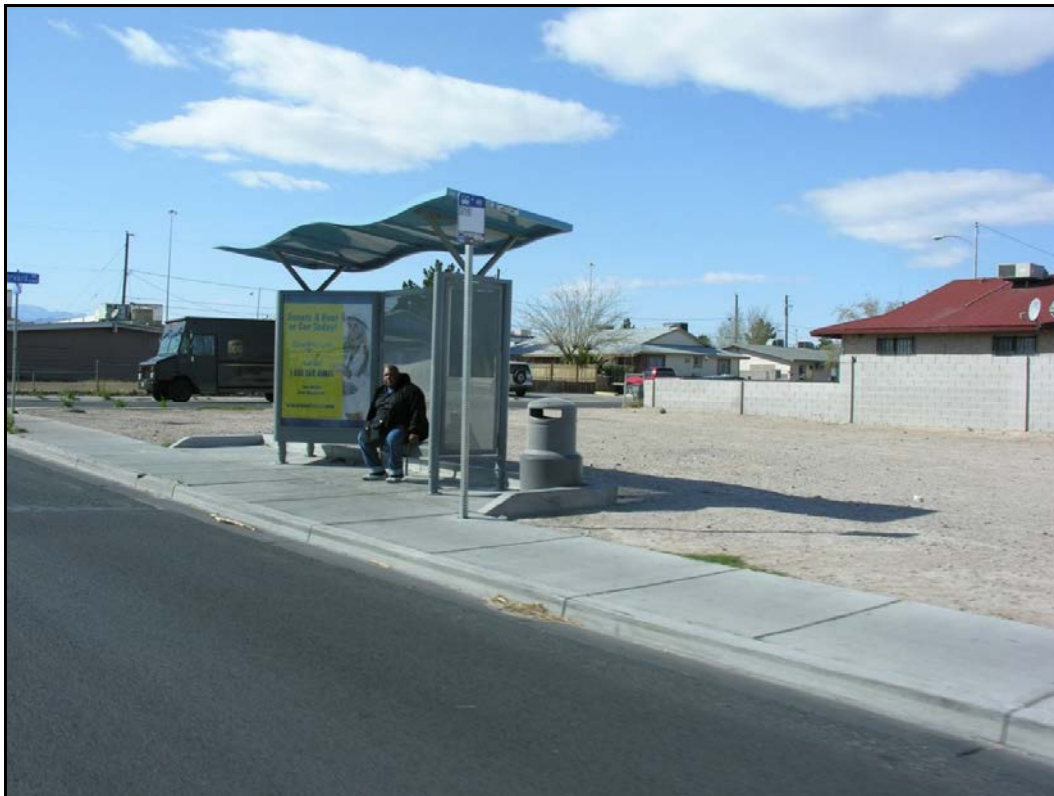
Figure 6: Las Vegas Valley Bus Shelter Located On Bus Pad Behind Sidewalk

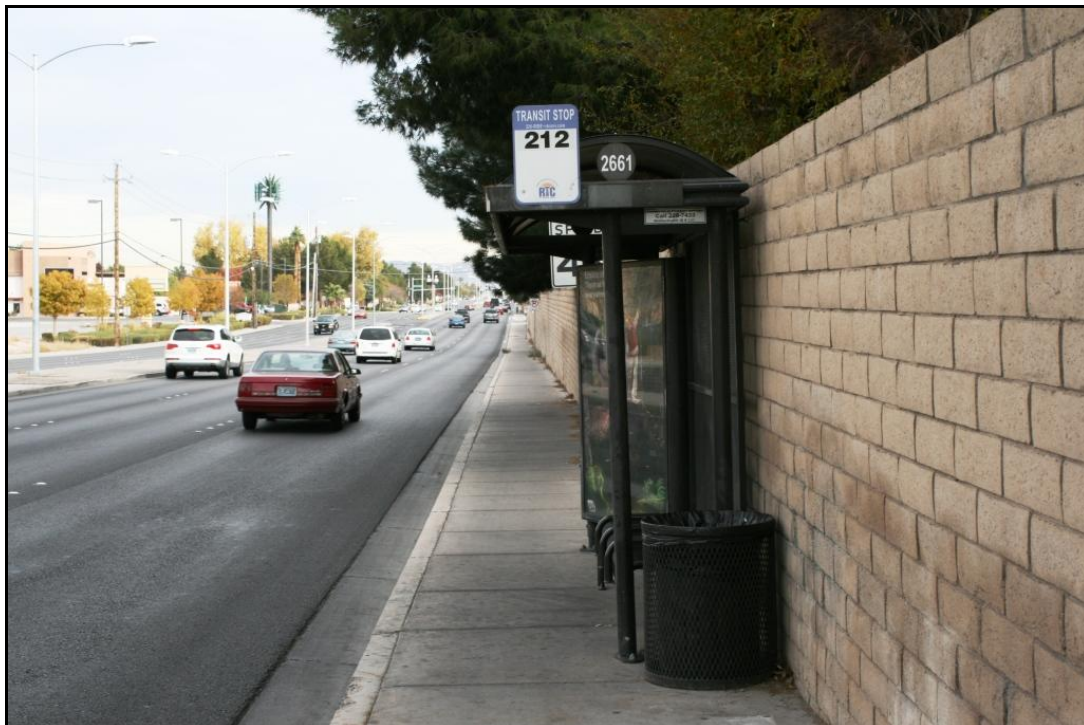
Figure 7: Las Vegas Valley Transit Shelter Located Against A Block Wall

Figure 7 is an example of a transit shelter that is located against a block wall. This transit shelter could be moved to a different location that offers a greater offset distance from the curb or other positive protection measures could be implemented.

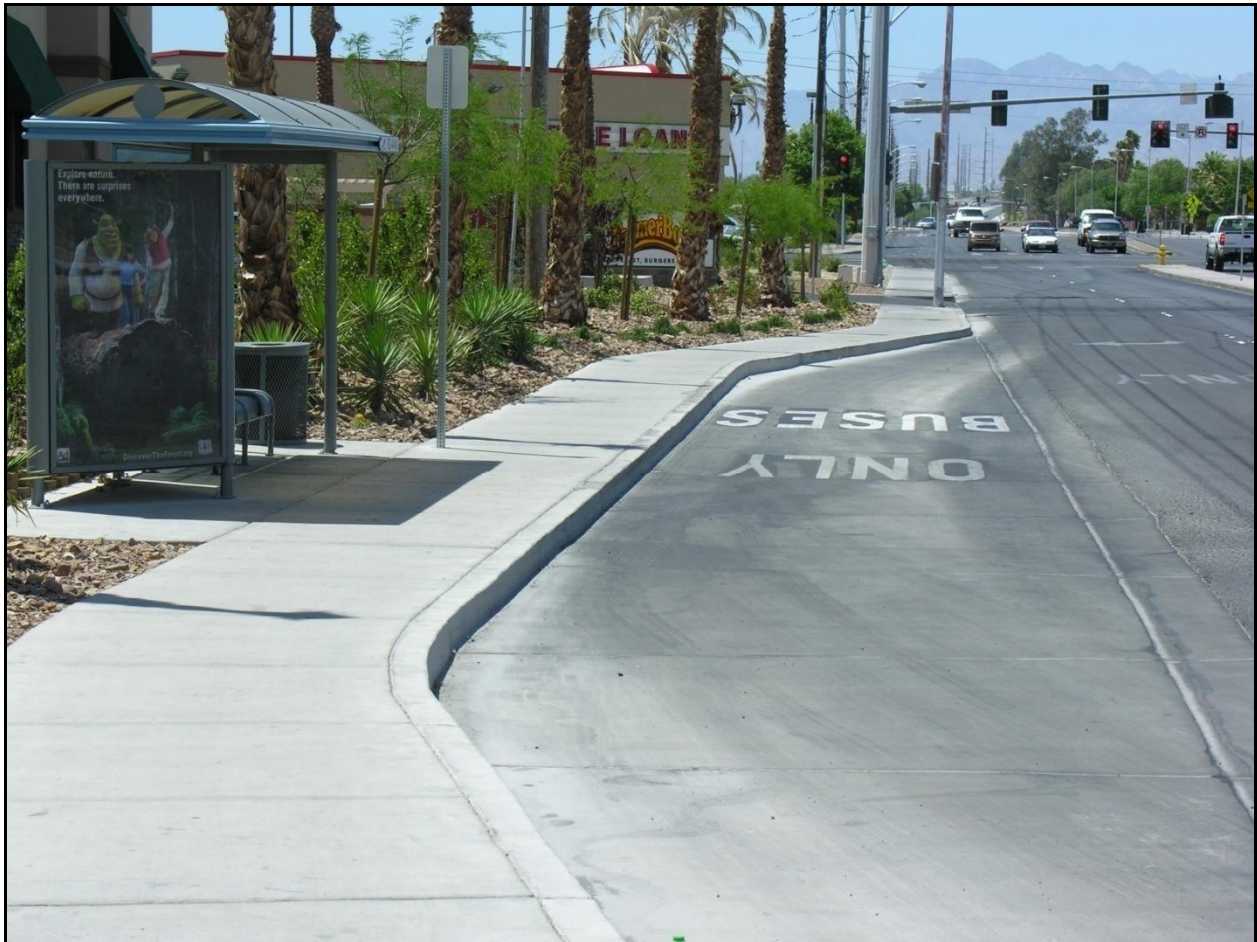
Figure 8: Las Vegas Valley Bus Turnout

A bus turnout, or bus bay, is a special zone on the side of the main roadway for buses to stop in order to pick up and drop off passengers. The purpose of the bus bay is to help buses avoid blocking a lane of traffic and to improve passenger safety during boarding and alighting. Additionally, bus turnouts add extra distance between the vehicles traveling on the roadway and the transit shelter. An example of a bus turnout in the Las Vegas Valley can be viewed in Figure 8.

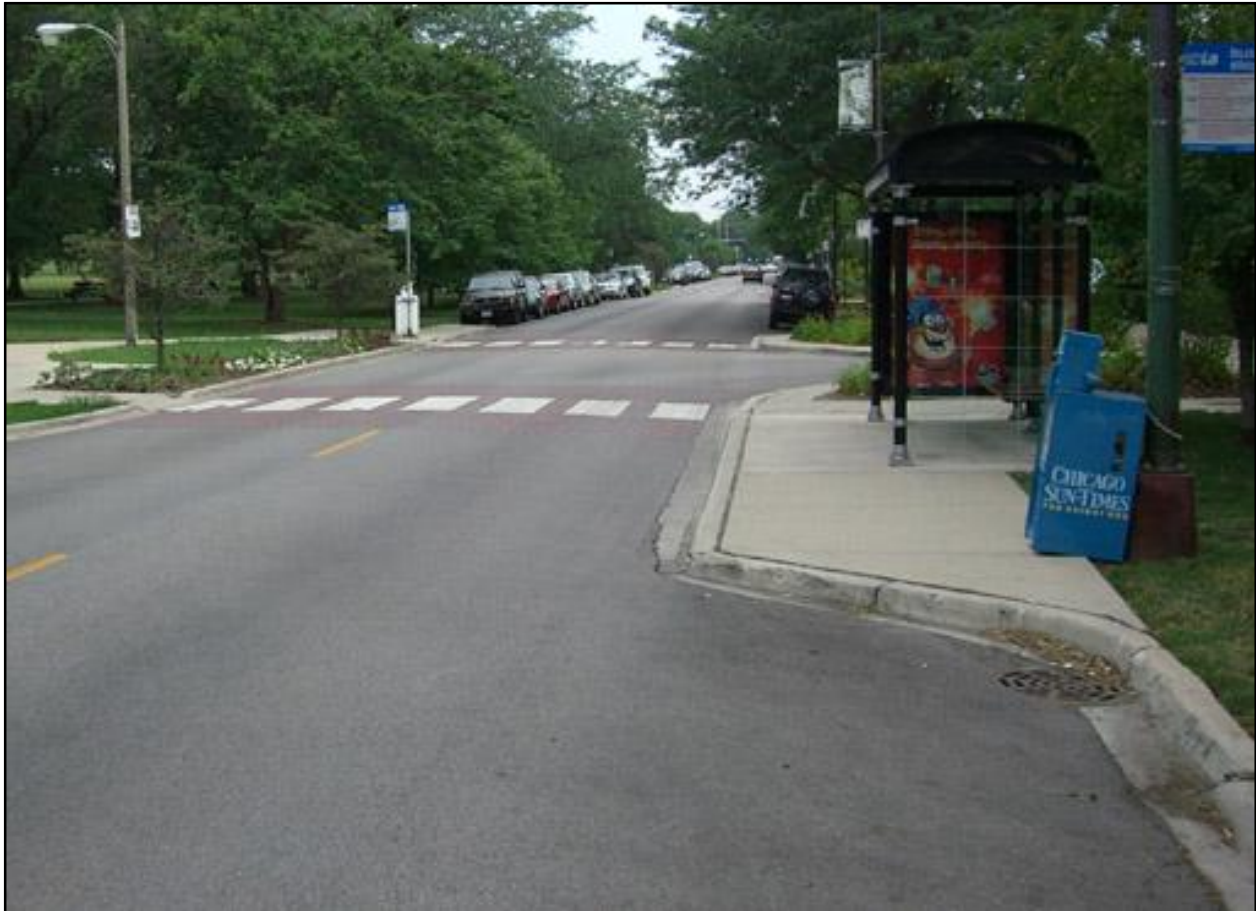
Figure 9: Bus Bulb¹⁵

A bus bulb, or bus boarder, is where a sidewalk is extended outwards for a bus stop and typically it replaces a portion of an existing parking lane. The purpose of the bus bulb is to allow a bus to stay in its traffic lane to pick-up and drop-off passengers, without having to pull over to the curb. Similar to bus turnouts, bus bulbs add extra distance between the vehicles traveling on the roadway and the transit shelter. An example of a bus bulb can be viewed in Figure 9.

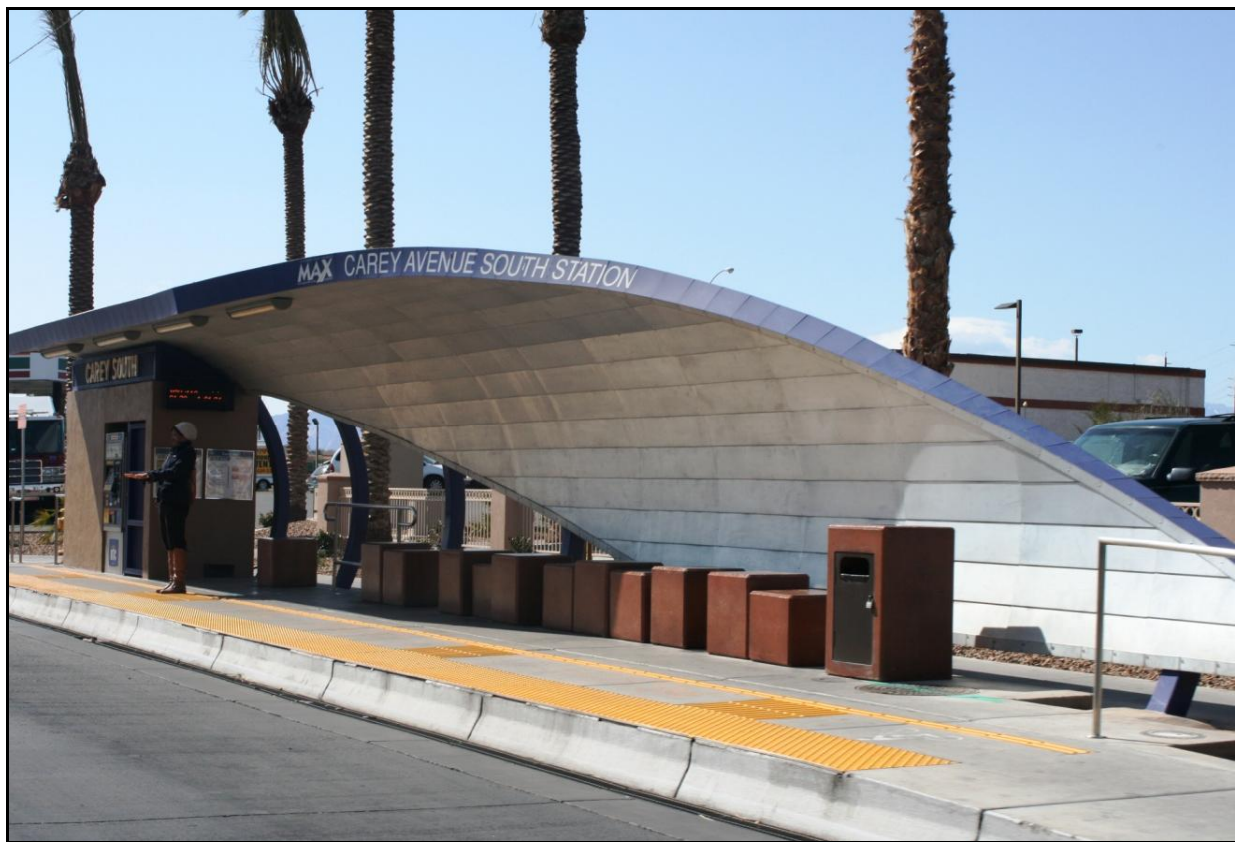
Figure 10: Raised Curb At Las Vegas MAX Stop

Level boarding already exists at some of the Las Vegas MAX transit shelters and along the Sahara and Boulder Highway BRT routes. The curb height along these alignments is 10 or 11 inches to accommodate the vehicles in use, and this height is much less effective in redirecting a vehicle than the 14 or 15 inch height mentioned in the APTA document. As such, raising the curb height as a safety measure is marginally effective, given the types of crash incidents experienced and the types of transit vehicles in service locally. Figure 10 illustrates the curb height at a Las Vegas MAX stop and Figure 11 illustrates the ease of riders boarding and leaving the Las Vegas MAX.

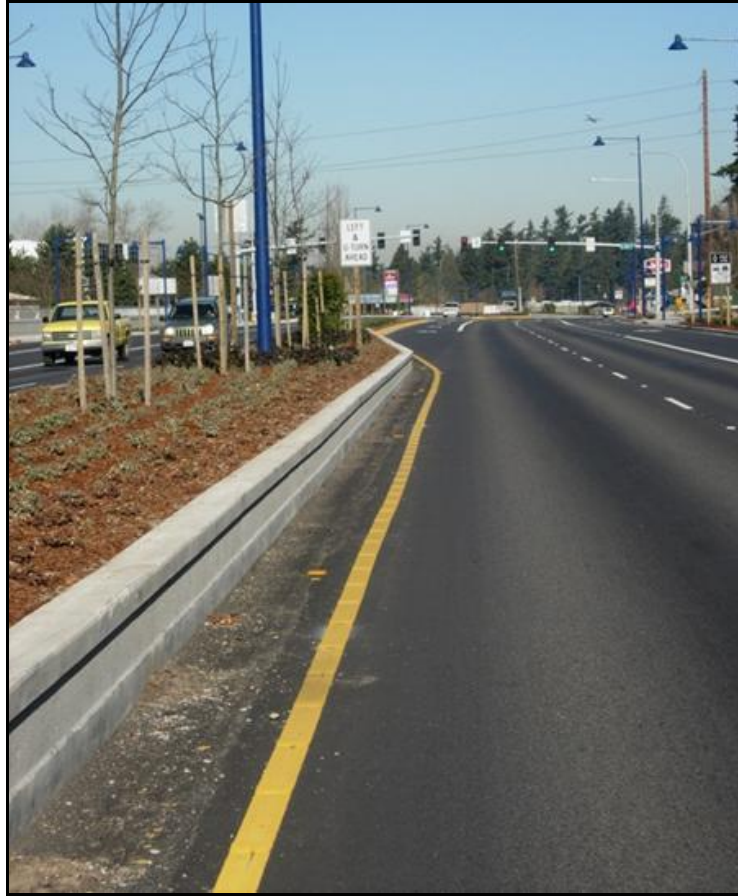
Figure 13: Low Profile Barrier In Des Moines¹⁸

The *2011 AASHTO Roadside Design Guide* recognizes low profile barrier rails as an acceptable barrier on roadways with a speed limit of 45 mph or less. They are an alternative to high containment curbs and raised curb options previously described. Barriers are described in more detail later in this document.

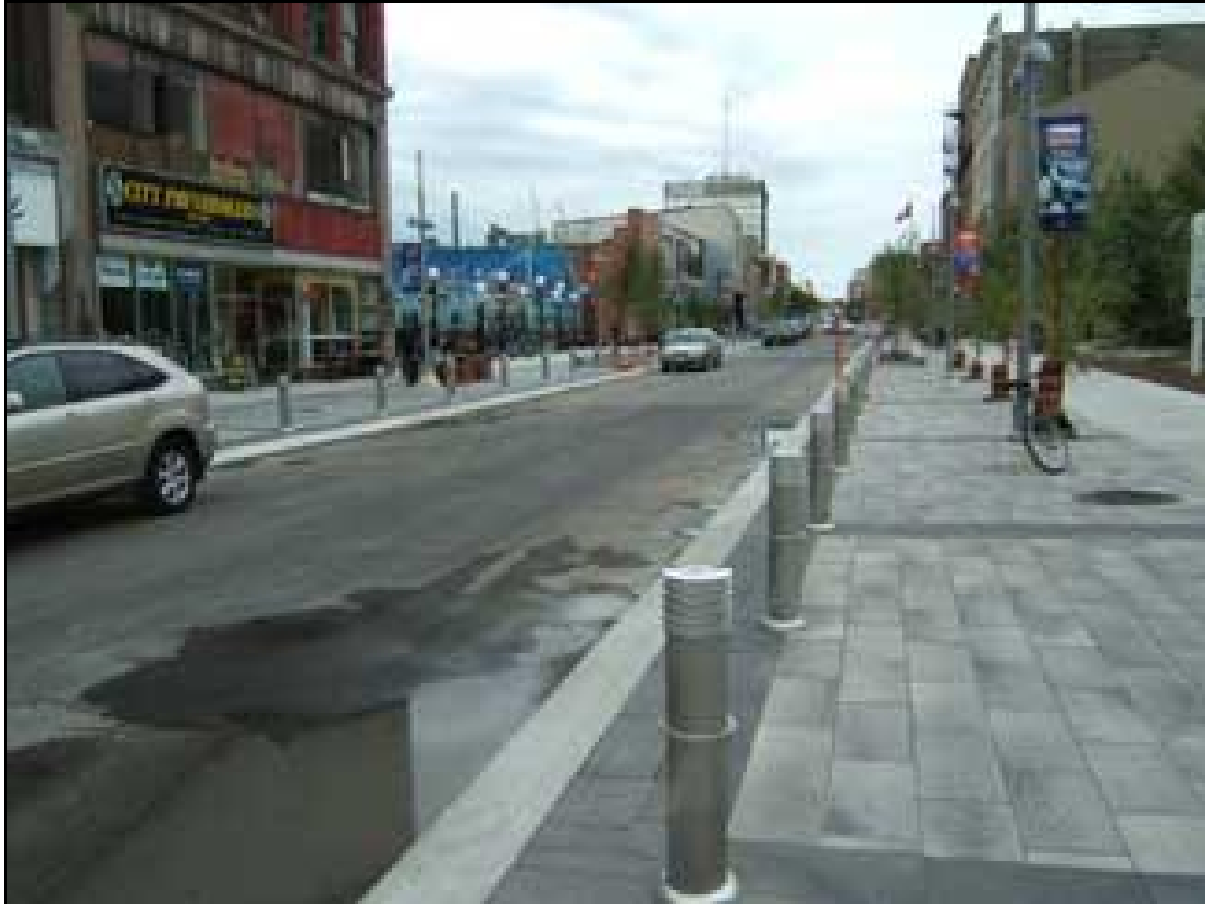
Figure 15: Bollards Separating The Roadway And The Sidewalk²³

Bollards are an available option, when other measures cannot be implemented, to help reduce the number of vehicles crashing into transit stops. However, the safety of motorists cannot be ignored when adding bollards because little is gained by trading one type of injury for another. In addition, when determining the location of a transit stop, it would be desirable to utilize existing features to shield and protect transit passengers; such as existing utility poles, trees, and fire hydrants. Since other measures such as moving transit stops away from the curb and providing landscape buffers are recognized successful primary strategies, bollards should only be considered after these measures are not feasible. Additional bollard information can be found in the Appendix.

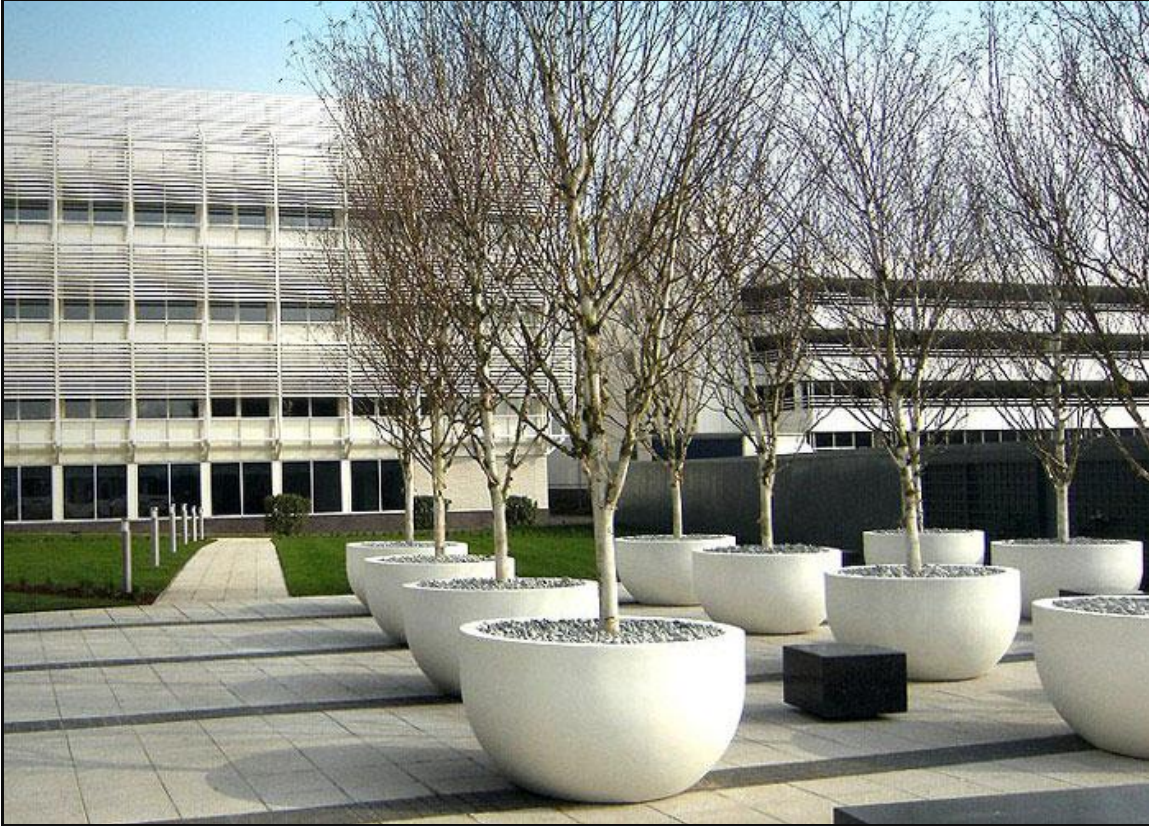
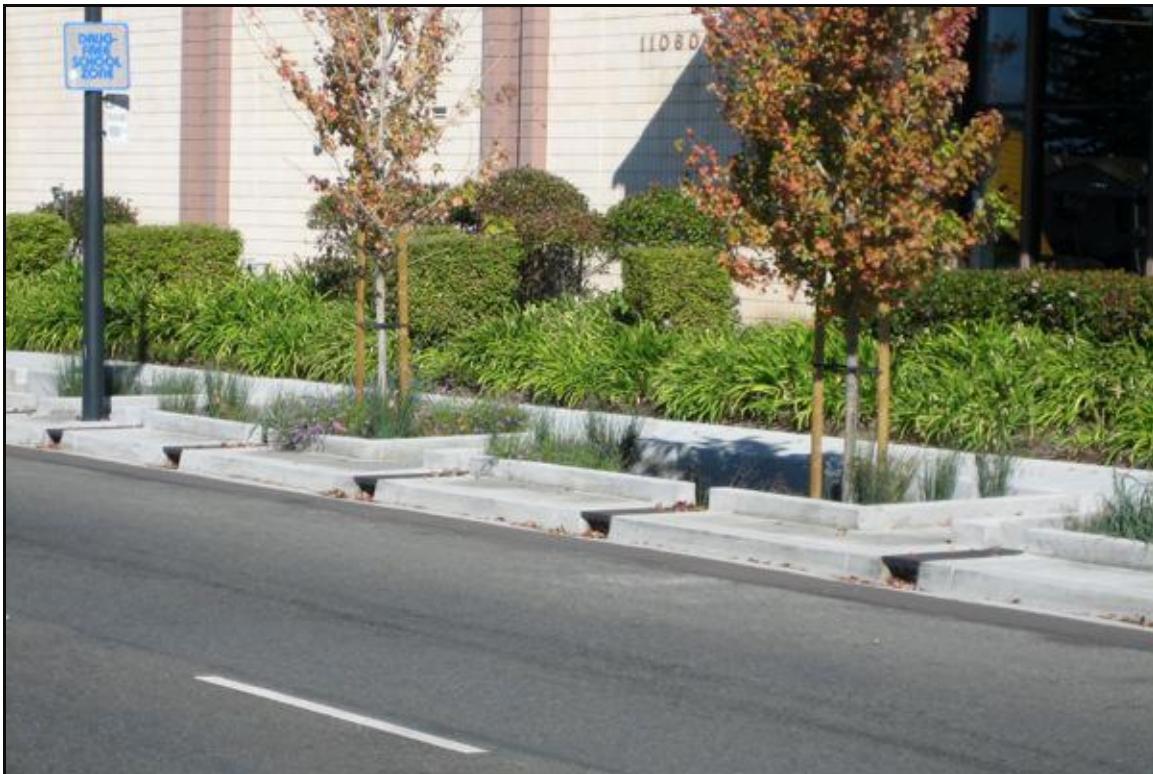
Figure 17: Concrete Planters With Trees²⁵

Figure 18: Concrete Planters With Trees²⁶

Concrete planters with trees, placed in front of transit shelters, would not only provide shade but they could help stop or slow down vehicles that are airborne, similar to the one described at the beginning of the document. However, the trees would have a negative effect on solar panel operation. If implemented, it is recommended that they are placed at least 6 feet from the edge of the curb.

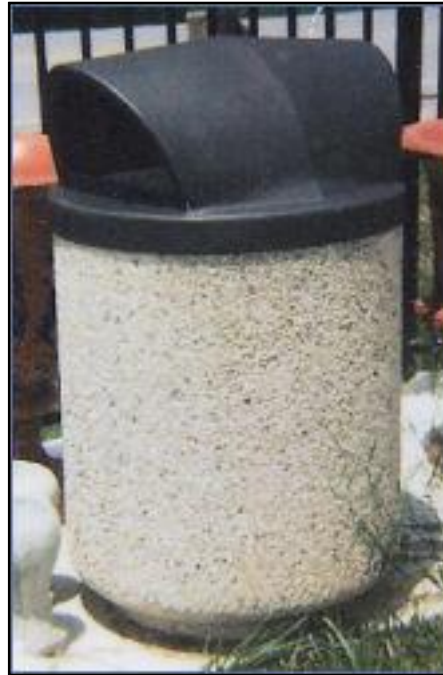
Figure 19: Concrete Trash Receptacle²⁷

Similar to concrete planters, the concrete trash receptacle can double as a bollard. They can be cast-in-place with reinforcing steel to act as a barrier between an on-coming vehicle and a transit rider. An example of a concrete trash receptacle can be viewed in Figure 19.

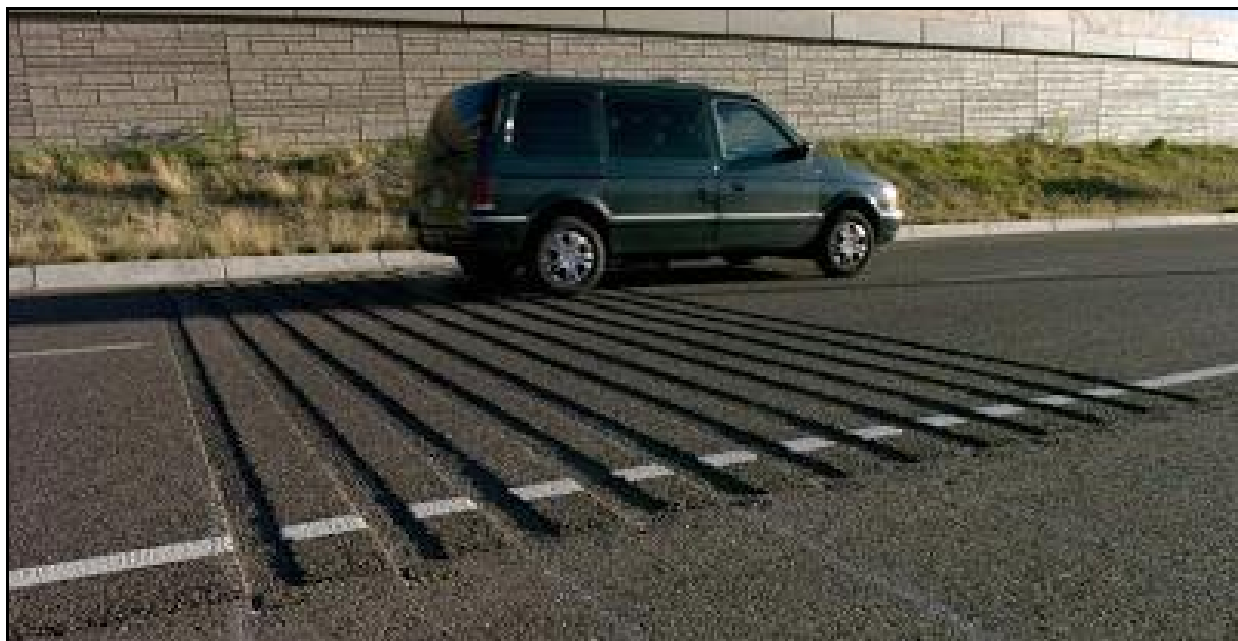
Figure 23: Roadway Rumble Strips³⁰

Two types of rumble strips that could be used in this situation include transverse rumble strips and shoulder rumble strips. Transverse rumble strips are either raised bars or grooves placed across the travel lane. They would be placed on the far outside lane only, which would cause cars to avoid traveling in the lane closest to the sidewalk to steer clear of the rumble strips. The further a vehicle is away from the curb, the less likely it is to run off of the road. An example of transverse rumble strips can be viewed in Figure 23.

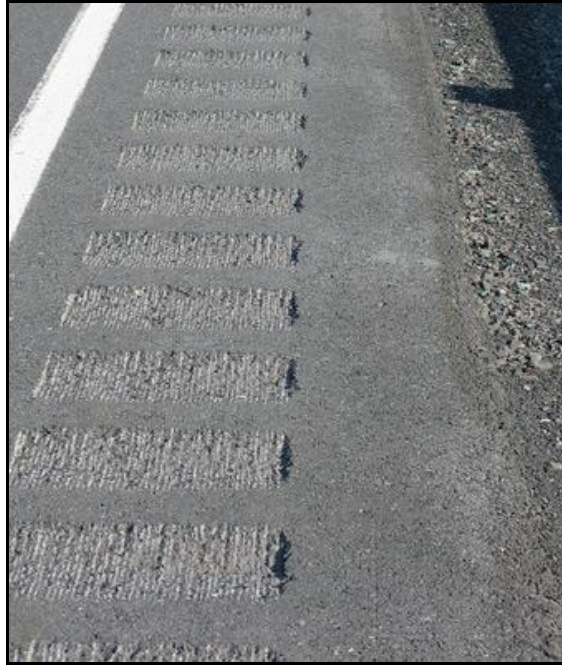
Figure 24: Shoulder Rumble Strips³¹

Shoulder rumble strips are either raised bars or grooves placed along the edge of the curb. They would help alert drivers if they started to get too close to the edge of the curb and the sidewalk. If a driver is alerted that they are too close to the curb, they will adjust their vehicle and avoid running off of the road and crashing into a transit shelter. An example of a shoulder rumble strip along the edge of the road can be viewed in Figure 24, an example of a shoulder rumble strip separating the edge of a roadway and a bicycle lane can be viewed in Figure 25, and an example of a shoulder rumble strip at a bus stop in the United Kingdom can be viewed in Figure 26. Due to the impact to bicycle riders and the types of transit shelter crashes experienced locally, rumble strips should be used only where other measures are not available, or where site conditions demonstrate a driver lane drift problem.

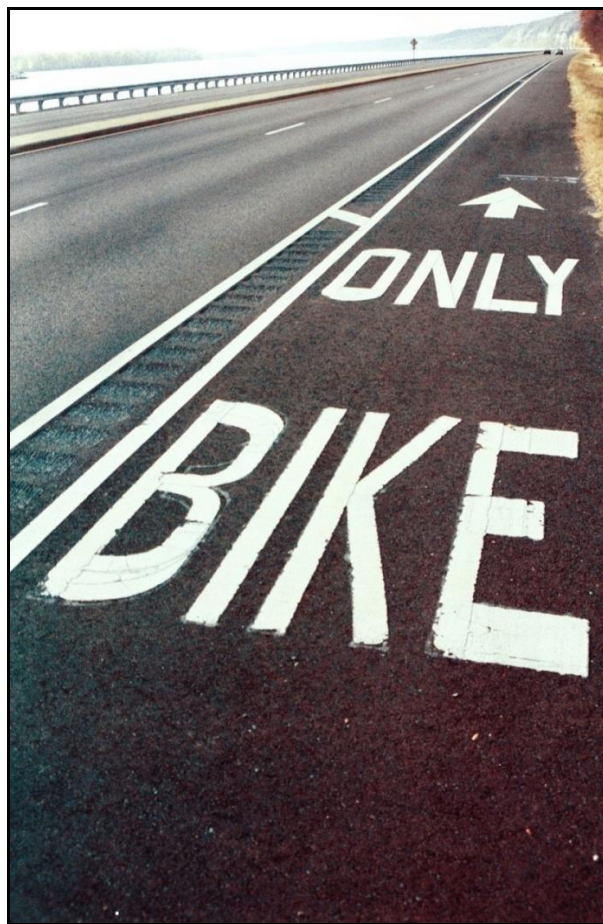
Figure 25: Shoulder Rumble Strips Between Roadway And Bike Lane³²

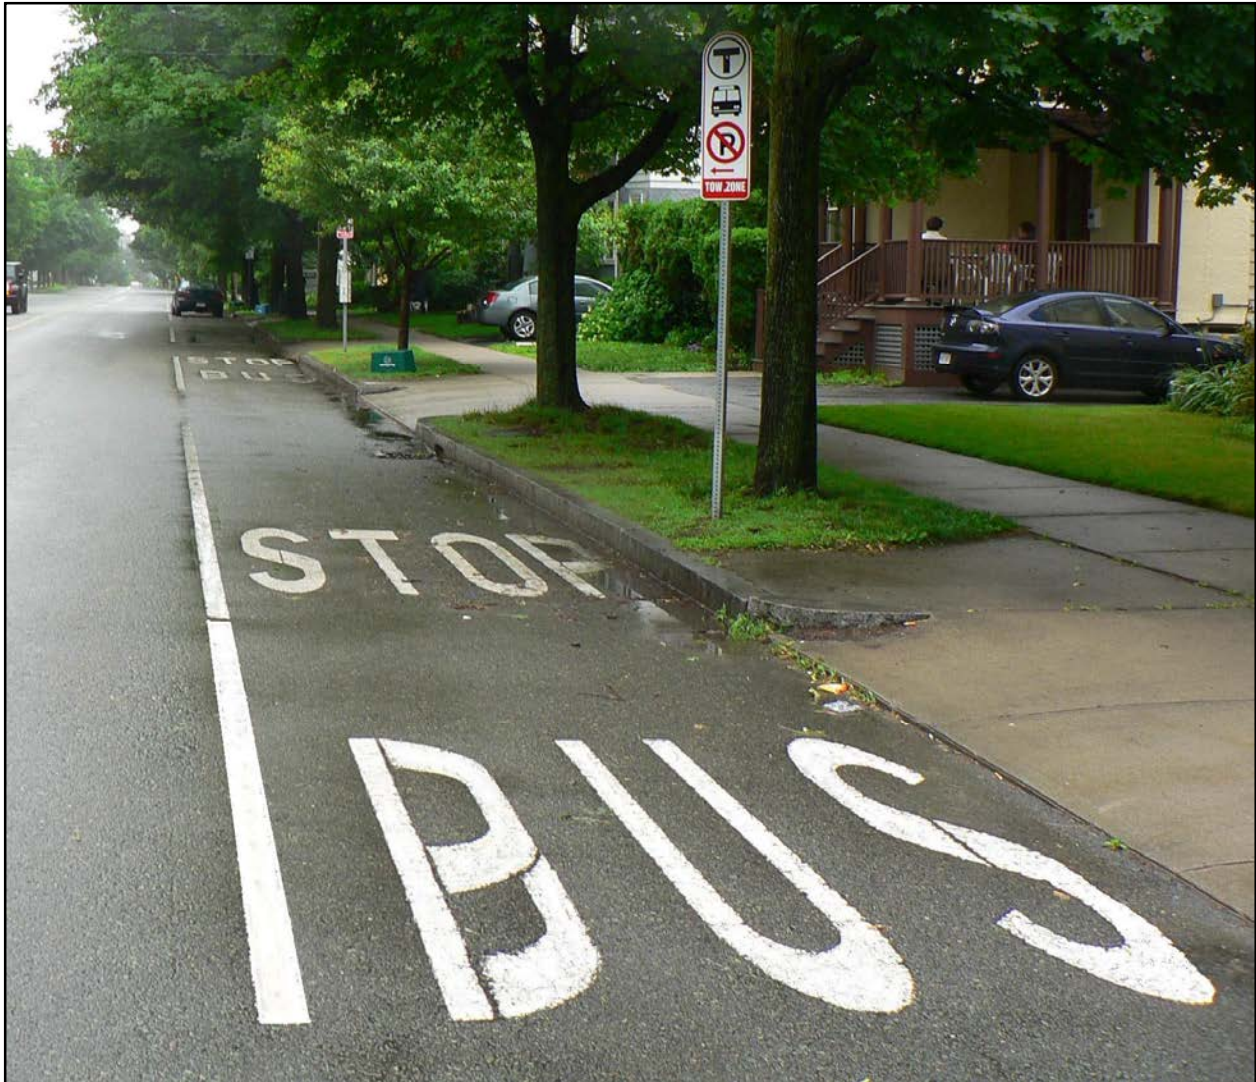
Figure 27: “Bus Stop” Pavement Markings In Massachusetts³⁴

Rumble strips, “Bus Stop Ahead” pavement markings, or a combination of the two would help drivers become aware that a transit stop is approaching. This awareness would help reduce the number of crashes that occur at transit stops each year.

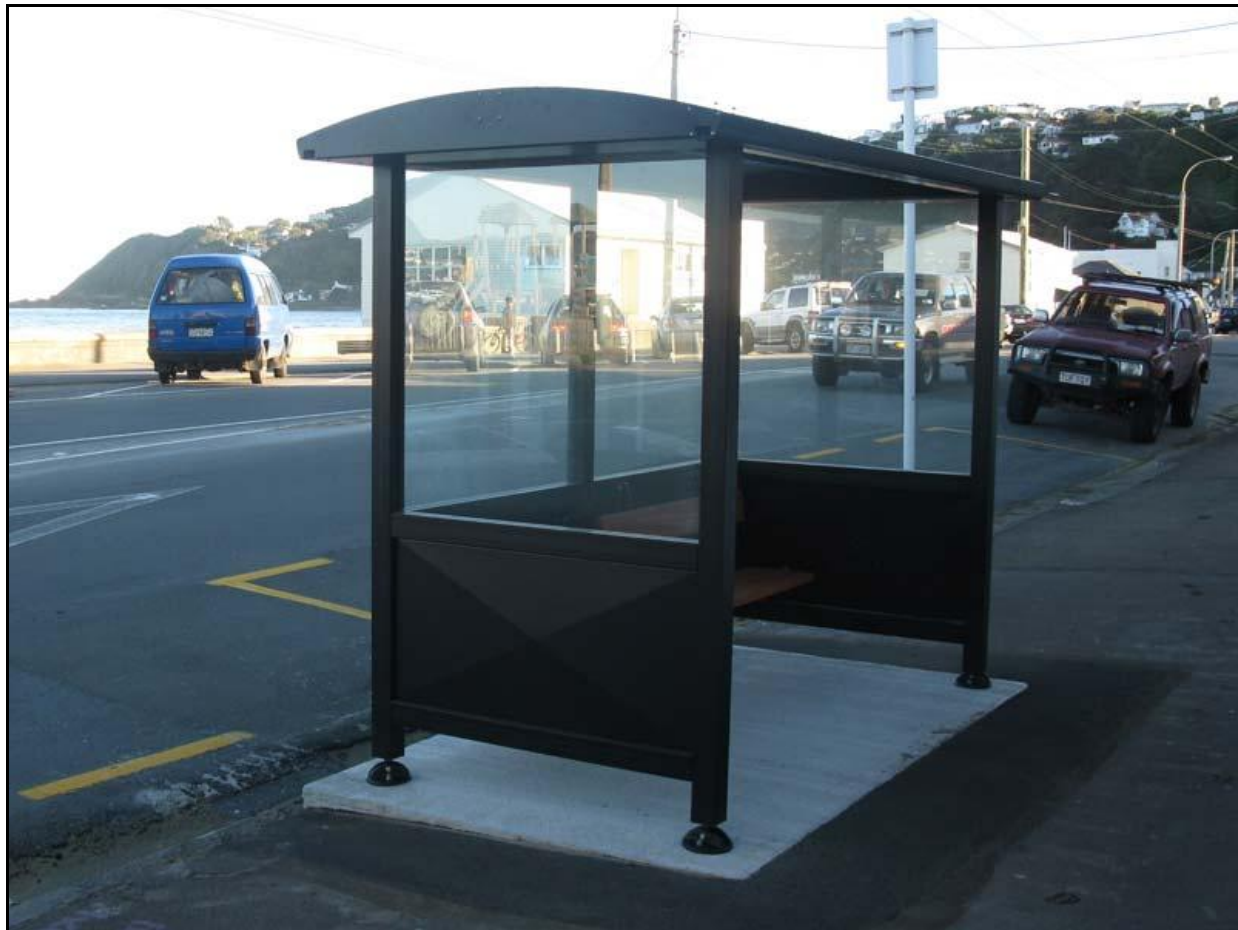
Figure 28: Rear-Facing Transit Shelter³⁵

- Rear-Facing Transit Shelters – rather than having the transit shelters open facing the road, transit shelters could be designed to have a protective barrier between the roadway and the shelter. The design would have to accommodate for easy access in and out of the shelter and still allow for riders to sit and see if a bus is approaching. An example of a rear-facing transit shelter can be viewed in Figure 28. Note: This would require a redesign of the current general market shelters to accommodate advertising panels that do not restrict visibility. In addition, this option normally places the shelter closer to the curb, therefore supplemental protection measures may be needed.

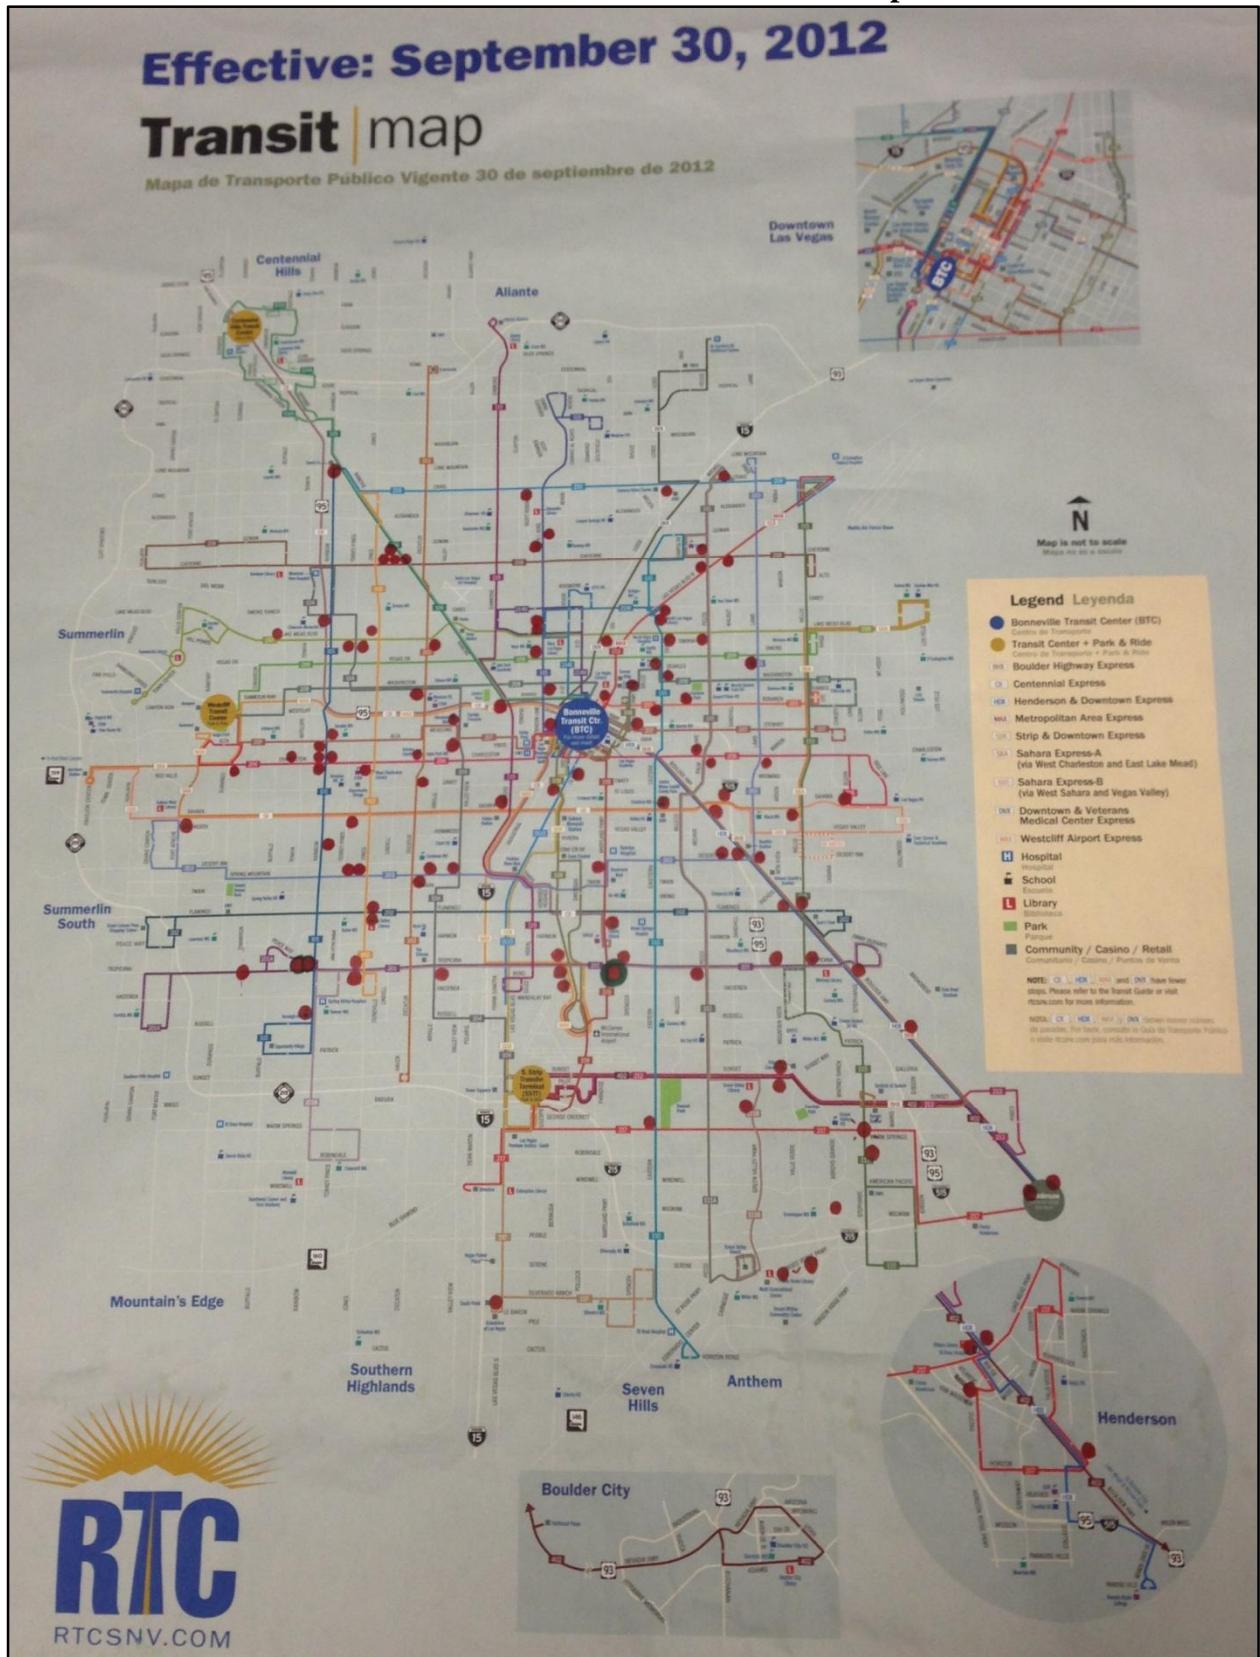
Vehicle to Transit Shelter Crashes – Map

7	SB NELLIS BLV S/O SAHARA AVE WS			On Sidewalk	No ROW	Turnout
8	EB LAKE MEAD BLV E/O TORREY PINES DR SS			Behind Sidewalk		Turn Lane
9	NB MLK BLV N/O GOWAN			On Sidewalk	No ROW	Block Wall
10	WB SPRING MOUNTAIN RD W/O ARVILLE ST NS			On Sidewalk	No ROW	
11	EB TROPICANA AVE E/O ARVILLE ST SS			On Sidewalk	No ROW	
12	SB EASTERN AVE S/O OWENS WS	0	3	On Sidewalk	No ROW	
13	WB CHARLESTON BLV W/O RAINBOW BLV NS			Behind Sidewalk		Phase II
14	EB CHARLESTON E/O LAMB SS	0	1	On Sidewalk	No ROW	
15	EB SPRING MOUNTAIN E/O DECATUR SS	4	8	On Sidewalk	No ROW	
16	EB Craig E/O Clayton	0	0	Behind Sidewalk		3' pad
	TOTAL	5	18

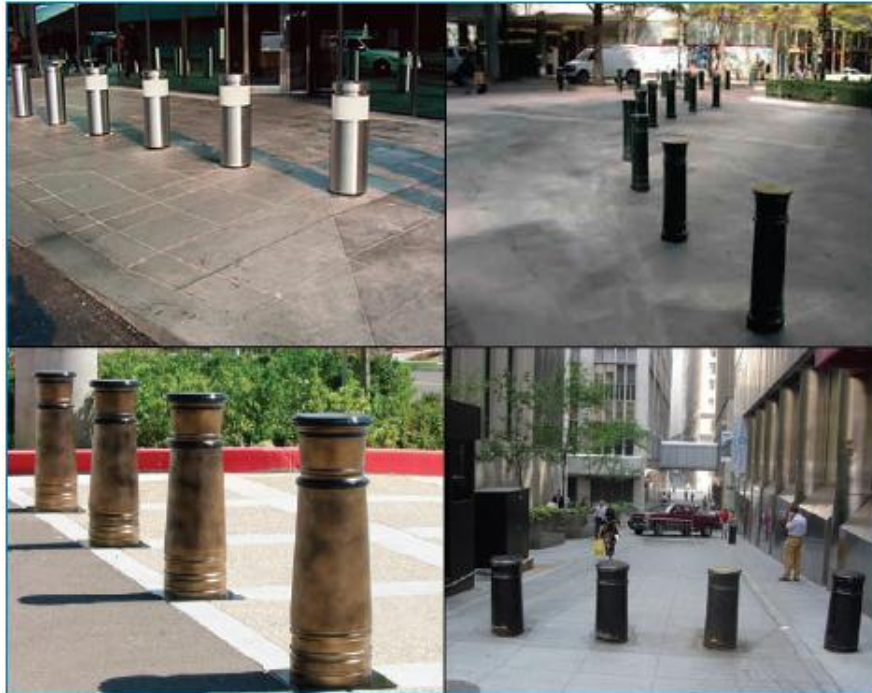
Bollards can be specified with ornamental steel trim attached directly to the bollard or with selected cast sleeves of aluminum, iron, or bronze that slip over the crash tube. Bollards can be galvanized against corrosion and fitted with internal illumination for increased visibility. Figure 2 shows a number of decorative bollards with high-performance ratings. Bollards may be custom designed for an individual project to harmonize with the materials and form of the building, but to ensure adequate protection, they would need to be tested by an independent laboratory.

Figure 2: Decorative bollards with high-performance ratings.

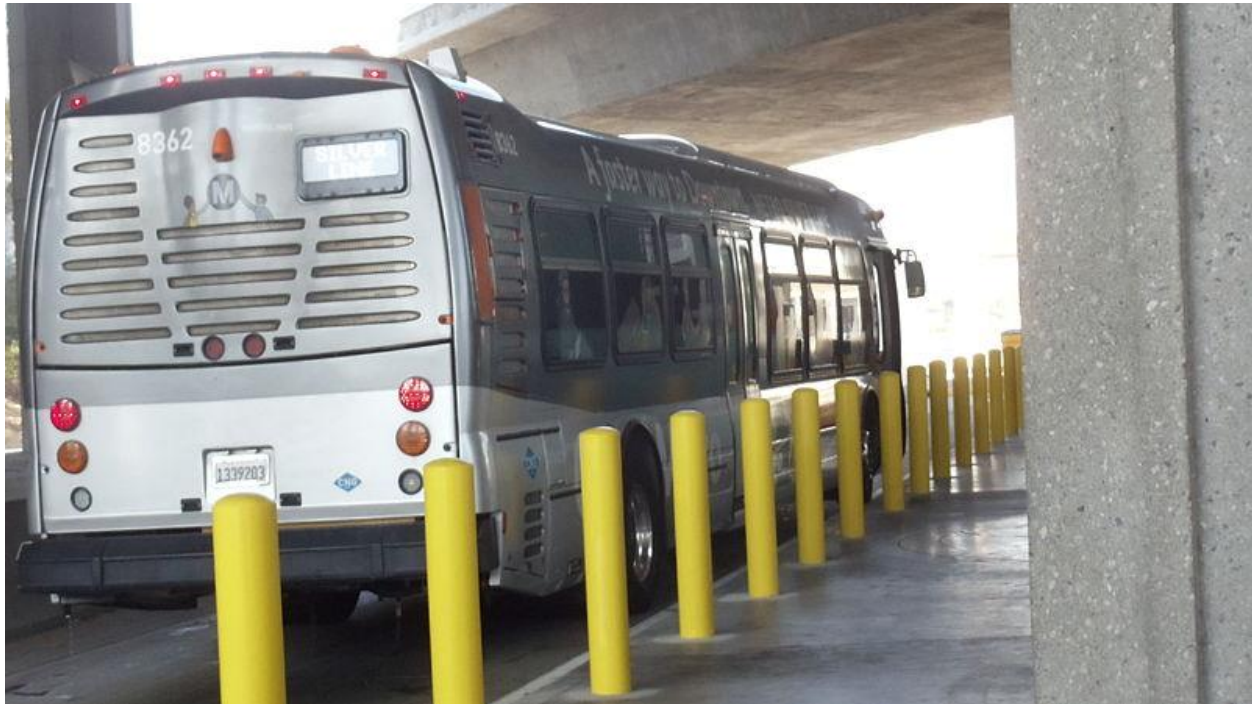
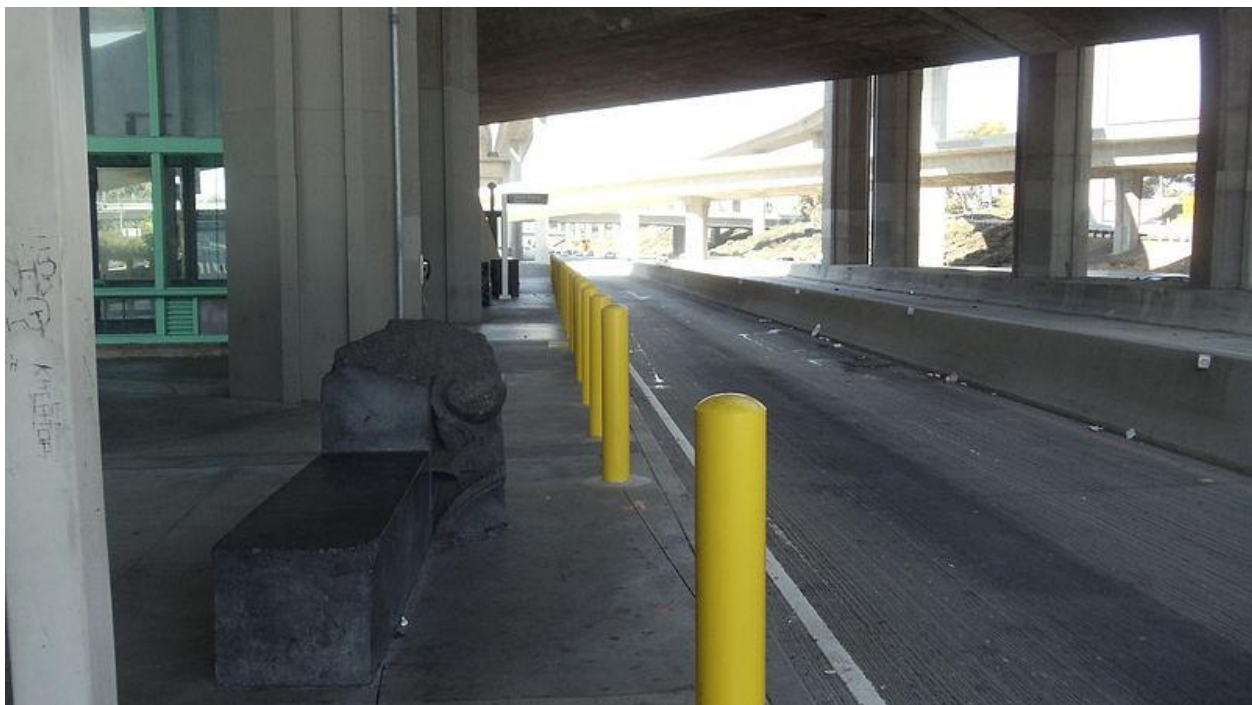
2012 at the station. Bollards were also installed at the 37th Street/USC Metro Silver Line Station as well.

Bollards installed at Harbor Freeway, Silver Line Station to enhance pedestrian safety
